Tribal Science in Action:

Case Studies from Bois Forte Environmental Services' Indoor Air Quality (IAQ) Program

2) Using blower door airtightness tests, infrared thermography, visual inspections and building code study to diagnose construction flaws in new homes

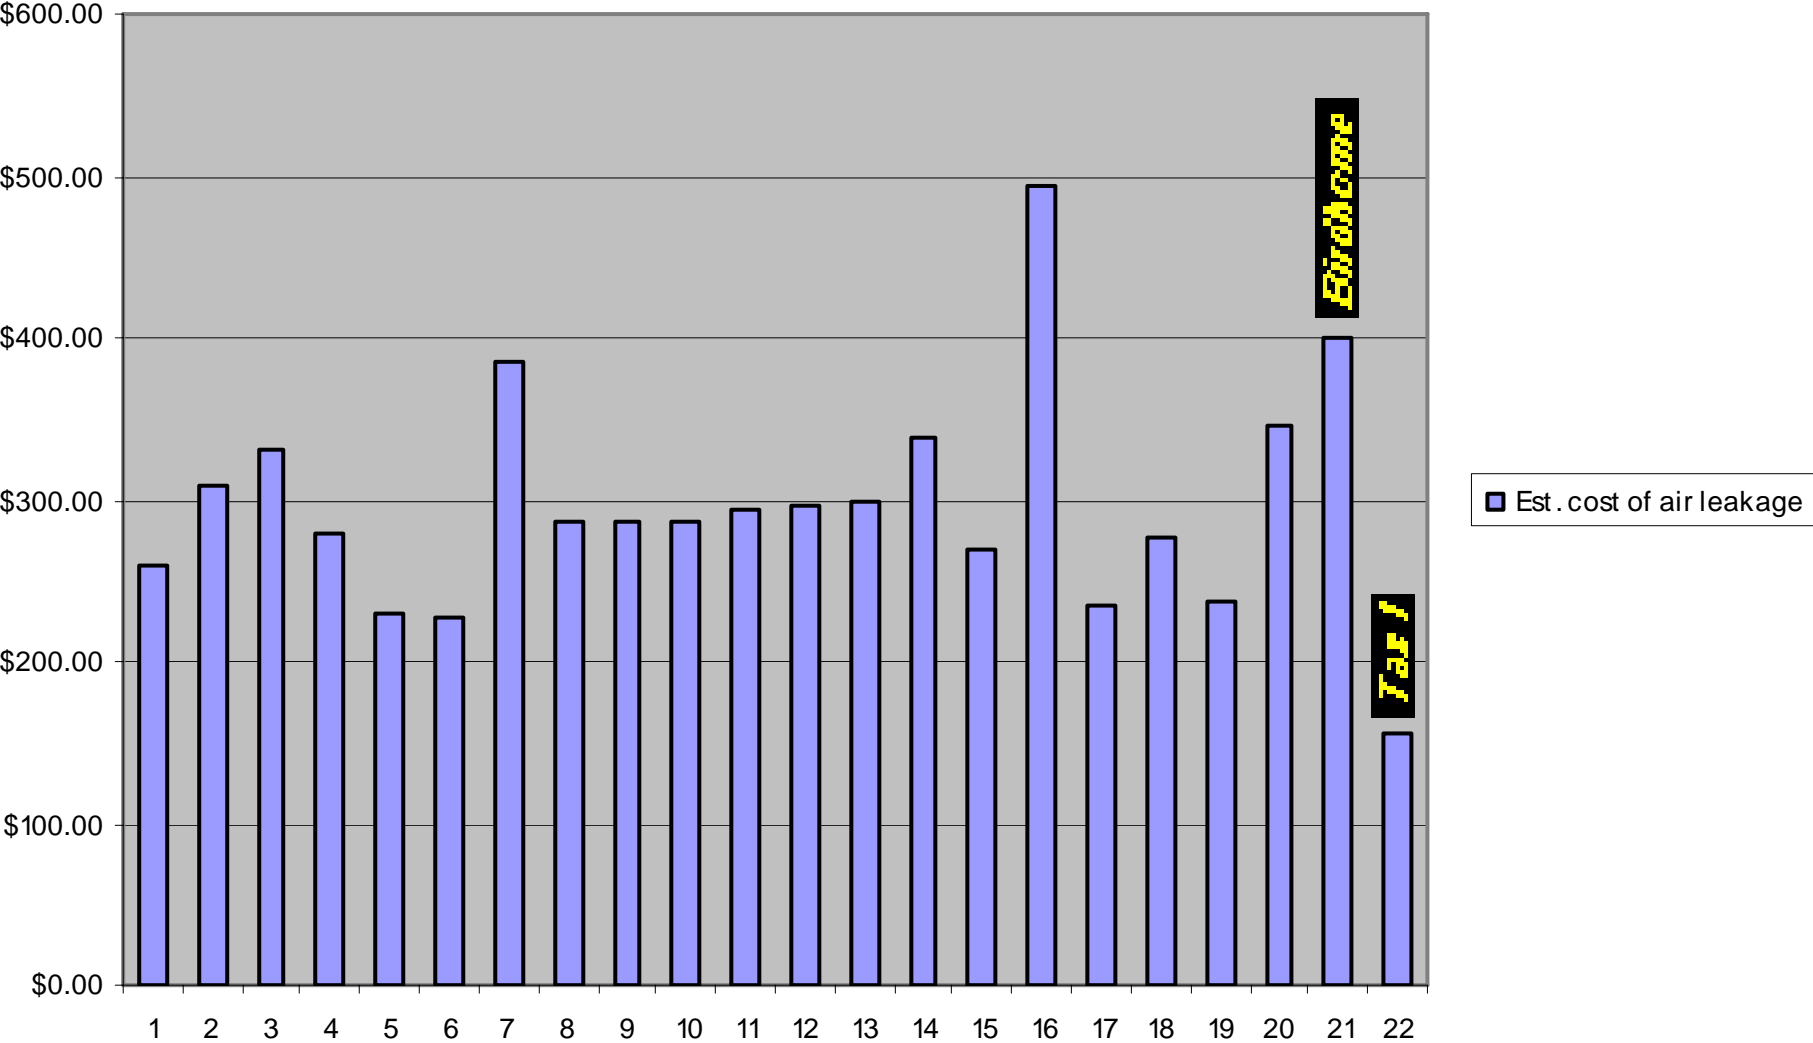
All 20 homes were found to have consistently poor airtightness values.

Compared to the airtightness portion of the Energy Code (adopted to the MN State Building Code April 15, 2000), the homes were all found to be between 3 to 5 times leakier than the building code allows.
